CASE STUDY OF SETTLEMENT DURING DOUBLE-O-TUBE TUNNELING IN SENSITIVE SOFT GROUND

Tadashi HASHIMOTOⁱ⁾, Guan-lin YEⁱⁱ⁾, Xian-feng MAⁱⁱⁱ⁾ and Kiyoshi HAYAKAWA^{iv)}

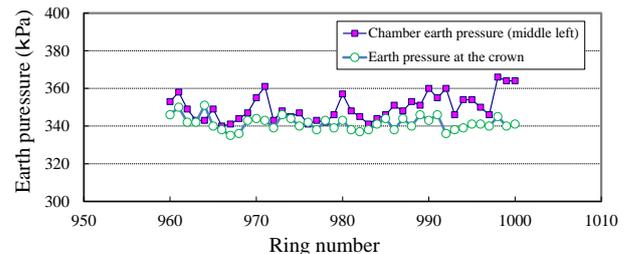
Fig.3 Earth pressure around section 1

(1) As shown in Fig. 3, the earth pressure at the chamber was 350 ± 10 kPa (middle left position). It was almost equal to the in-situ earth pressure at the crown (340 kPa). However, the chamber pressure was larger than the theoretical value (about 280 kPa). Besides the unsuitable operation of the shield machine, there exists the possibility of malfunction of the pressure gauge.

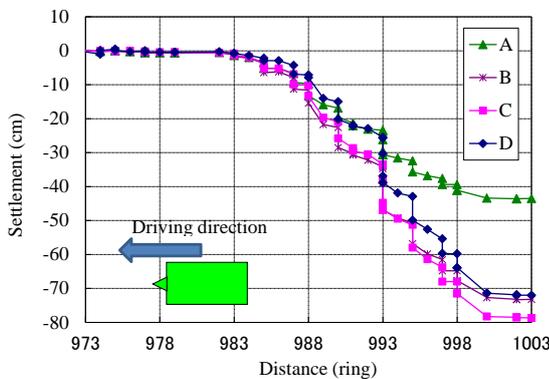
Fig.4 Observed surface settlements versus distance (Section 1) due to shield driving

Fig.4 shows the observed ground surface settlement of section 1. The horizontal axial is the advance distance of shield machine, which is presented by the ring number. The vertical axial is settlement. The position of the shield machine is plotted in the figure. Although no obvious settlement or upheave can be seen before shield machine arrived and during machine passed by, settlement occurred after tail passed. A maximum settlement about 80 cm occurred in measure point C, where is the center of the DOT tunnel. A smallest settlement about 43cm was observed in point A, where located at the side of the tunnel. It can be seen that the settlements above the tunnel center and two tunnel axial lines are almost the same, while those at the sides are much smaller. All settlements converged after 16 rings.

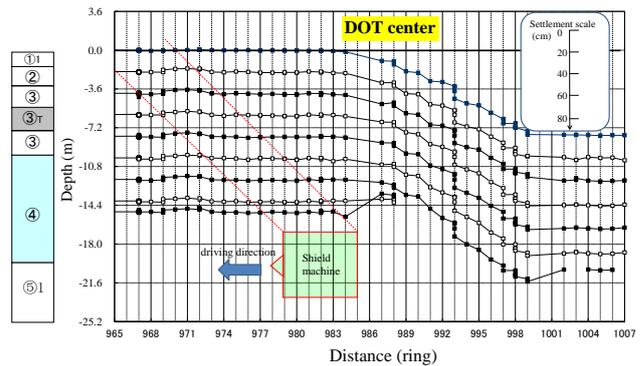
Fig.5 Change of subsurface settlements (Section 1)

Fig.5 shows the subsurface settlement of section 1. The horizontal axial is the advance distance of shield machine, which is presented by the ring number. The vertical axial is depth from ground surface. The settlement scale, the position of the shield machine, and the 45° influence lines of cutter face and tail void are plotted in the figure.

(3) During the tail passing by, the ground 2m above the tunnel crown upheaved. The maximum upheave of 16.7cm occurred above the seagull segment (the center line of the tunnel). The upheaving also can be seen in the ground 4m above the tunnel. However, due to the large upheave, the magnet settlement gauge at the bottom failed.

(4) After the tail passing by, the ground above the tunnel subsided together. The maximum settlement was -94cm, which was observed in the magnet of 12m depth

above the seagull segment. At the distance of No.1000 ring, this magnet upheaved a little due to the complementary grouting from the segment.

Aforementioned phenomena indicate that the earth balance at the cutter face and the friction of the skin plate did not affect the ground very much. However, the improper backfill grouting squeezed the surrounding ground, resulting an upheaving of the ground near the shield machine. The tail void was not filled in time, a large settlement occurred right after the tail passing by. It also can be seen that in Shanghai soft clay ground, the backfill grouting from segment, even though a complementary grouting is executed, cannot avoid the settlement.

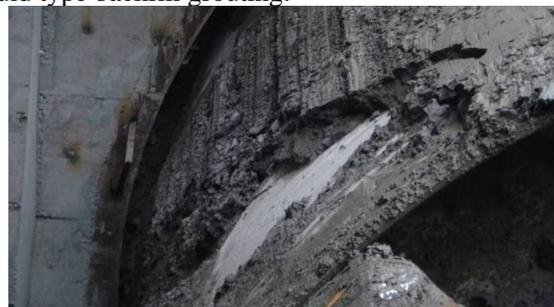
Fig.6 Agglomeration on the skin plate

After the DOT shield machine entered a middle shaft, it is found that a layer of cement-like agglomeration attached on the skin plate (Fig.6). The maximum thickness of the agglomeration was about 20cm. From the scrape on the agglomeration, it can be deduced that the agglomeration has been cut by the entrance. Therefore, the original thickness of the agglomeration should have been at least 40~50 cm. The staff of the construction company confirmed that no other material have been added to the ground during the shield excavation, except the bentonite slurry in the chamber and the backfill grouting. Therefore, the agglomeration should be the cementation of the two liquid type backfill grouting.

The mechanism for the large ground settlement can be concluded as following. After the pipes for simultaneous backfill grouting got clogged, the grouting was injected from the 3rd~5th ring of segment.

However, the soft ground has already fallen down to fill the tail void before the grouting from the segment. The grouting broke through the weak zone of the ground, or ran back along the gap between the ground and the skin plate. The two-liquid grouting got hardening quickly, and attached on the skin plate gradually, especially on the concave seagull segment. Consequently, the tail void became much larger than the theoretical value, result in a large settlement.

Two countermeasures were taken in the middle shaft. The two liquid type backfill grouting is compose of A (mainly cement) and B (mainly water glass) liquid. B liquid is mixed with A liquid at the operation platform of shield machine. Then the mixture is sent to the simultaneous injection pipe at the tail of shield machine through a transportation pipe. The mixture is sent by injection pump to fill the tail void during the shield advancing. The transportation pipe is about 6 m. On the other hand, the gel time is set within 10 seconds. It is easy to block the transportation pipe if the pipe is not cleaned in time after every injection. However, in this case, it was difficult for the shield machine operator to handle. Besides that, the pump for B liquid often failed due to lack of maintenance. Under these situations, it is decided that the priority should be set to filling the tail void in time and avoiding the conglutination of the grouting material on the skin plate.

Two-liquid type backfill grouting was changed to one-liquid type (non-cement type). At the same time, a complementary injection of cement fluid was carried out from the segment on the first gantry. By this way, the long term strength of the grouting material can be enhanced.

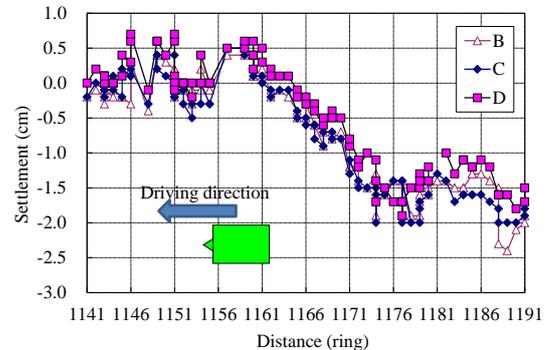
Fig.7 Change of surface settlements (Section 2) due to the reformed TBM driving

Fig.7 shows the ground surface settlement of monitoring section 2. A vertical displacement of ± 0.5 cm was observed before the shield arriving and during the shield passing by. A settlement occurred when the

tail passing by, and finally settlement was about 2 cm. The subsurface settlements gauges also showed the same tendency. Comparing with Fig.4, it can be said that the reformation have reduce the settlement effectively.
