TC304-TF3 COUNTRY REPORT

on
Troublesome Ground and Correspondence Technology
in Underground Construction
in Japan

Country
Japan

Tadashi Hashimoto - GRI
Makoto Kimura - Kyoto Univ.

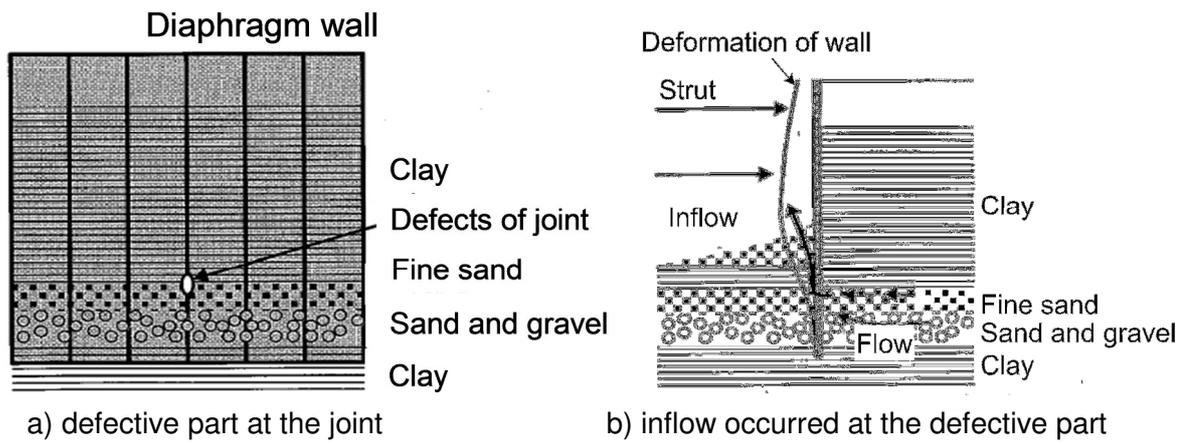
- Fig.1 (a) shows a flaw in cut-off wall appeared in a location between an upper clay layer and a lower sand layer. Even if the excavation depth has not reached the lower sand layer yet, it is also very possible that an inflow takeplaces, as shown in Fig.1(b) for example. In the case that a fine sand layer deposited upon a gravel layer with high permeability, the fine sand will flow with groundwater, and scouring effect will happen gradually, then it will result to the inflow composed with a lot of fine sand.

Fig 1 Inflow occurred by defective part in cut-off wall

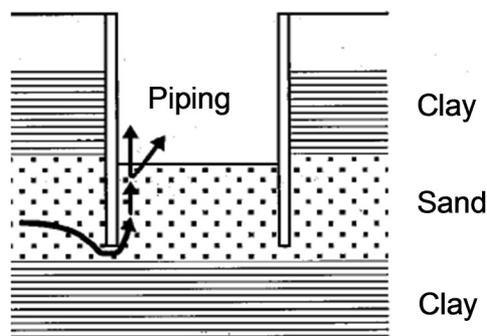
- Related to ②, inflow with piping might be caused by the shortage of the installation depth of the cut-off wall, because of lacking in ground information, for example, as shown in Fig.2. In the case of encountering a complex ground condition, it is necessary to conduct detailed geological investigation which focuses on the continuity of the stratum and insite pumping test in the purpose to grasp the sealing effects of a cut-off wall or ground improvement before the excavation work.

Fig 2 Inflow caused by shortage of installation depth of cut-off wall

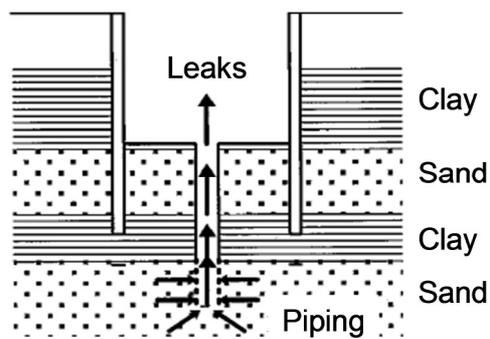
- There are many examples of inflow along remained bore holes or existing wells stated illustrated in Fig 3. To prevent this kind of inflow trouble, it is necessary to gather as more as possible the information on existing bore holes and wells, to take measure as much as possible for example sealing the existing bore holes by grouting. Moreover, it is necessary to require filling in of the borehole and well by thoroughly using seals material at the time of site investigation.

Fig 3 Inflow caused by fail sealing of bore hole or existing well

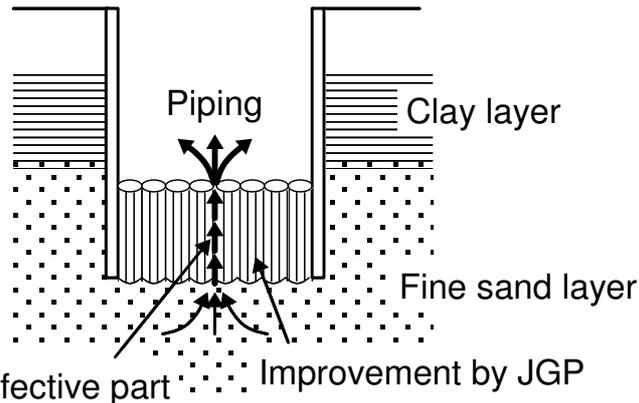
- JGP is often employed in the soil improvement to patch up the defective part of cut-off wall or as a countmeasure against uplift of an excavation bottom. It is not rare that an inflow occurs through the defective part or the lack of improvement illustrated in Fig4.

Fig 4 Inflow caused by defective part of soil improvement by JGP

- In order to cover this issue due to the defective improvement of the JGP, to enlarge the thickness of improvement, to employ a higher ability of JGP, to employ chemical grouting as an additional improvement, to conduct insite test for examination of sealing effect, and as well as to improve the quality of JGP work will be necessary.

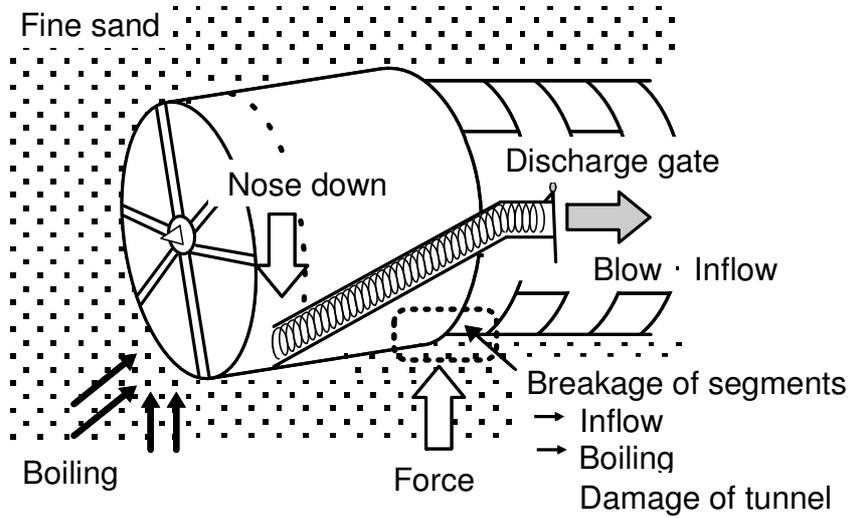
- In excavating by EPB (Earth Pressure Balance) shield machine in a fine sand ground, it is difficult to condition the excavated soil in chamber or on screw conveyor. By accident, the excavated soil could blows in like quicksand from the discharge gate(as shown in Fig.5). If large ground loss happened, subsequent nose down phenomenon is possible to occur by the boiling at the surrounding ground, and finally the extremely rising of the pressure at the tail of the shield is possible to cause the segmental lining damaged. It could also results to great cave-in in surface of ground in the case of the intense blow accident.

Fig 5 Inflow through discharge gate

- In order to prevent the occurrence of intense inflow, a water stop plug is to be formed sufficiently in a screw conveyor. It is useful for doring a tunnel not only in fine sand but also in gravel or cobble ground with high permeability.

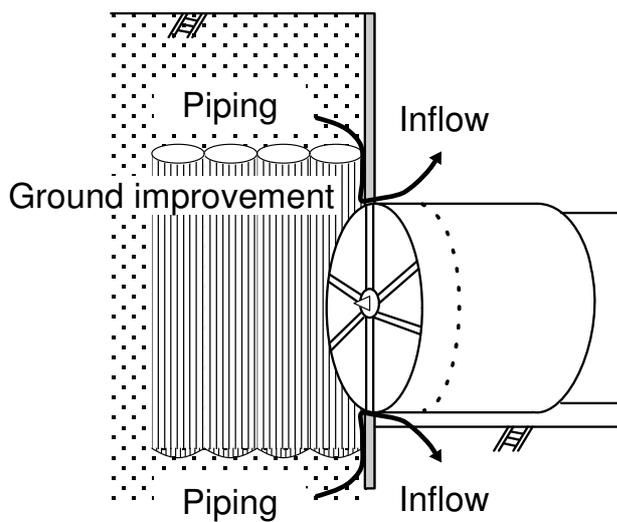
inflow of ground water containing fine sand may often occur because of the damaging in of the impervious wall

Fig 6 Inflow at langch / arrive shaft

- or the improved ground as shown in Fig. 6. As a countermeasure, it is recommend to conduct the additional chemical injection grout, as well as performing strict execution management.

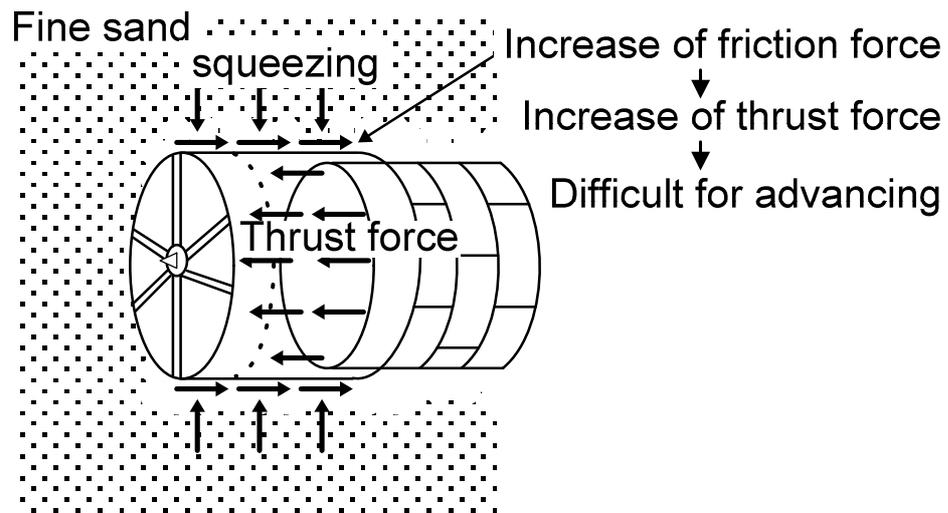
- It is often seen the trouble that the TBM is trapped in squeezing ground, during the boring in fine to medium sand with a small uniformity coefficient. The phenomenon caused by an increase of frictional resistance between a shield and the ground as shown in Fig.7. in consequently, extremely raising reaction force according to the large thrust jacking force caused in large deformation and damage of segmental lining, and the advancement speed of TBM is to be decreased for the shortage of excavation thrusts.
- As a countermeasure, it is effective to inject lubricated material into the gap behind the shield body, to make overcut more. It is also necessary to design more powerful TBM and lining when encountering these kinds of troublesome groundss.

Fig 7 Being trapped in squeezing ground of fine sand
